CR-179507 OCTOBER 20, 1986 21-5988

# THERMAL BARRIER COATING LIFE-PREDICTION MODEL DEVELOPMENT SECOND ANNUAL REPORT

# FOR NASA LERC CONTRACT NAS3-23945

# **GARRETT TURBINE ENGINE COMPANY**

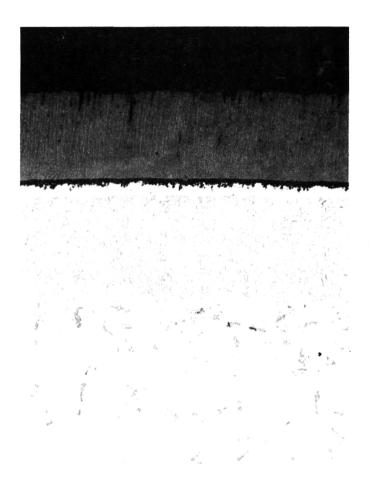
Figure 4-17. Inner Portion of EB-PVD Zirconia was Densified After 47 Hours in the 1170C Oxidation Test, 200X Magnification.

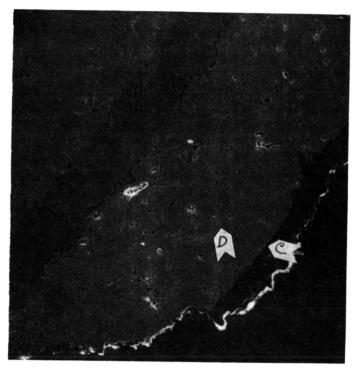
Figure 6-2. Zirconia Adjacent to the Surface Deposits was Densified on Klock Coated TFE731-5 HP Turbine Blades.
